Debris/Ice/TPS Assessment and Integrated Photographic Analysis for Shuttle Mission STS-51

October 1993

Gregory N. Katnik
NASA/Kennedy Space Center

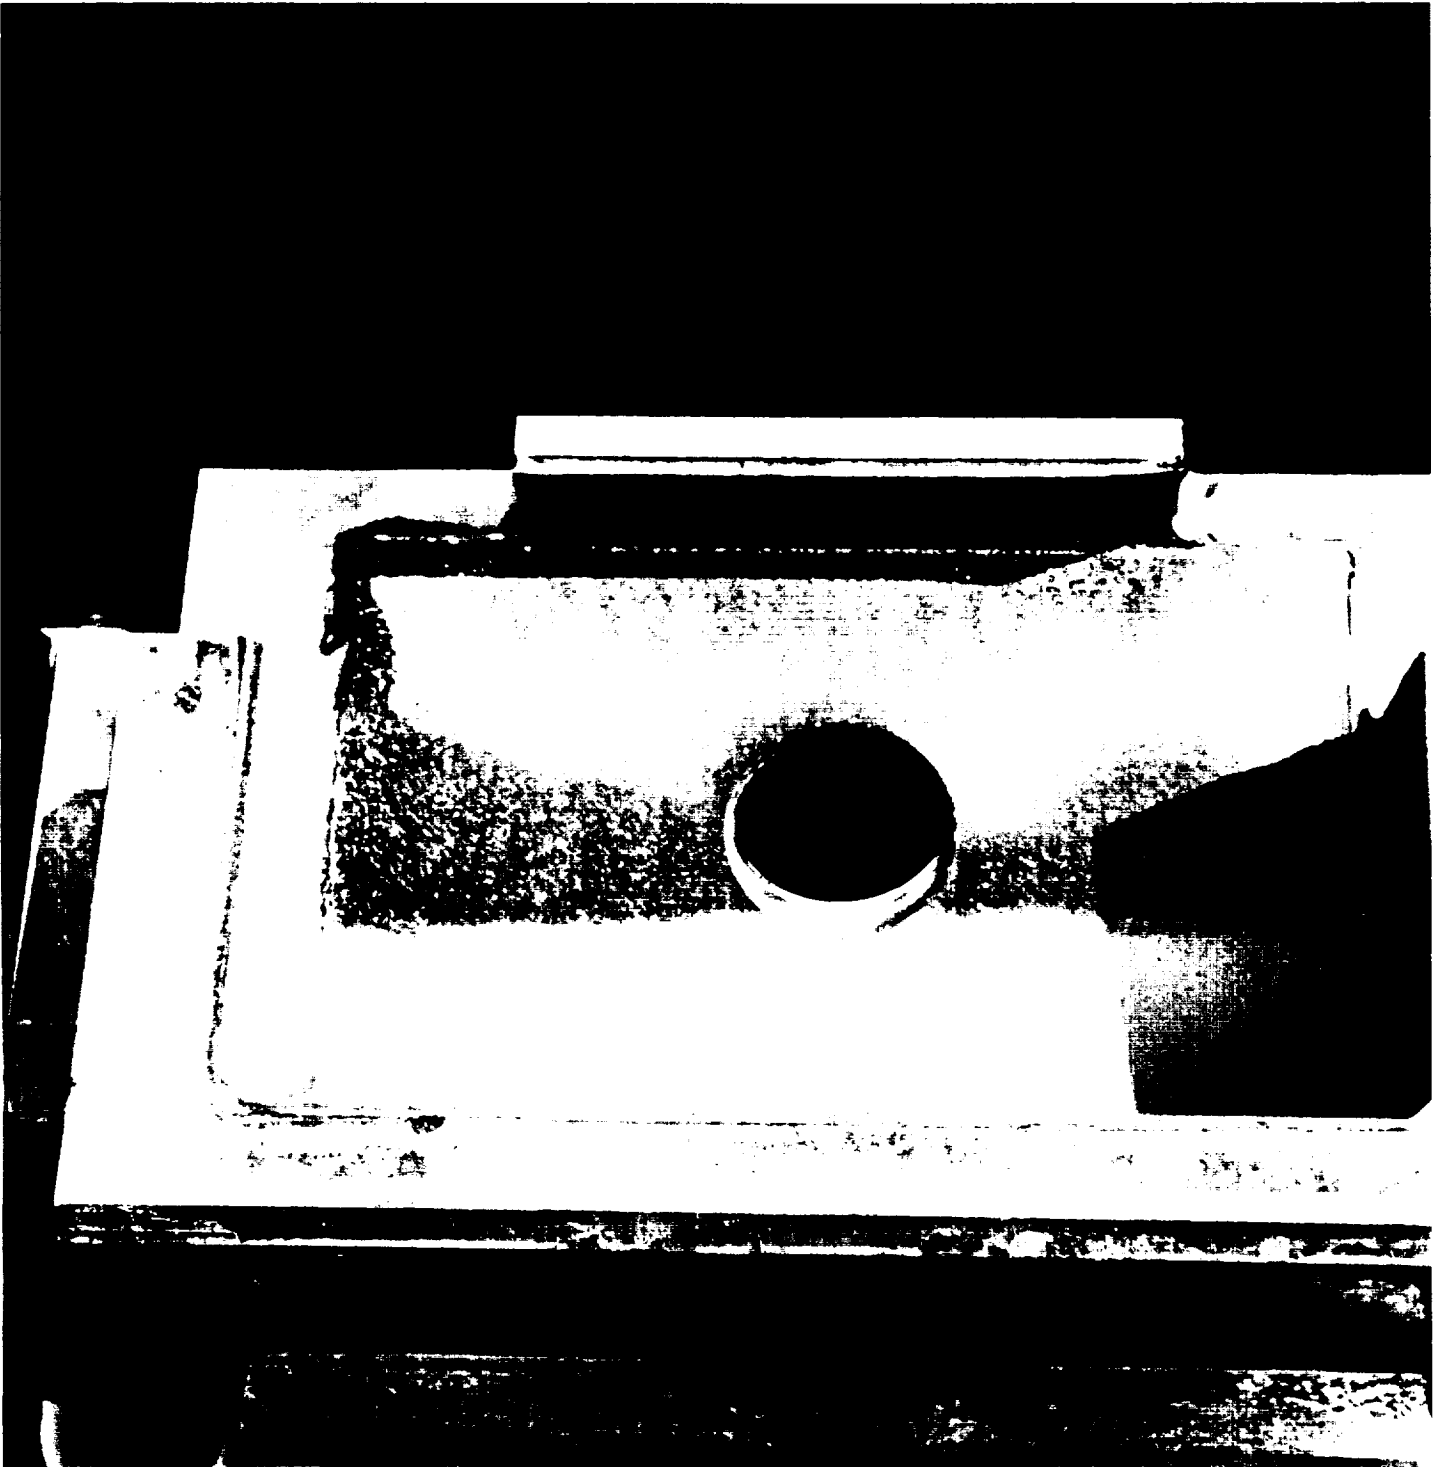
South SRB HDP erosion was typical. All south HDP EPON shim material was intact. There were no stud hang-ups on any of the holddown posts.

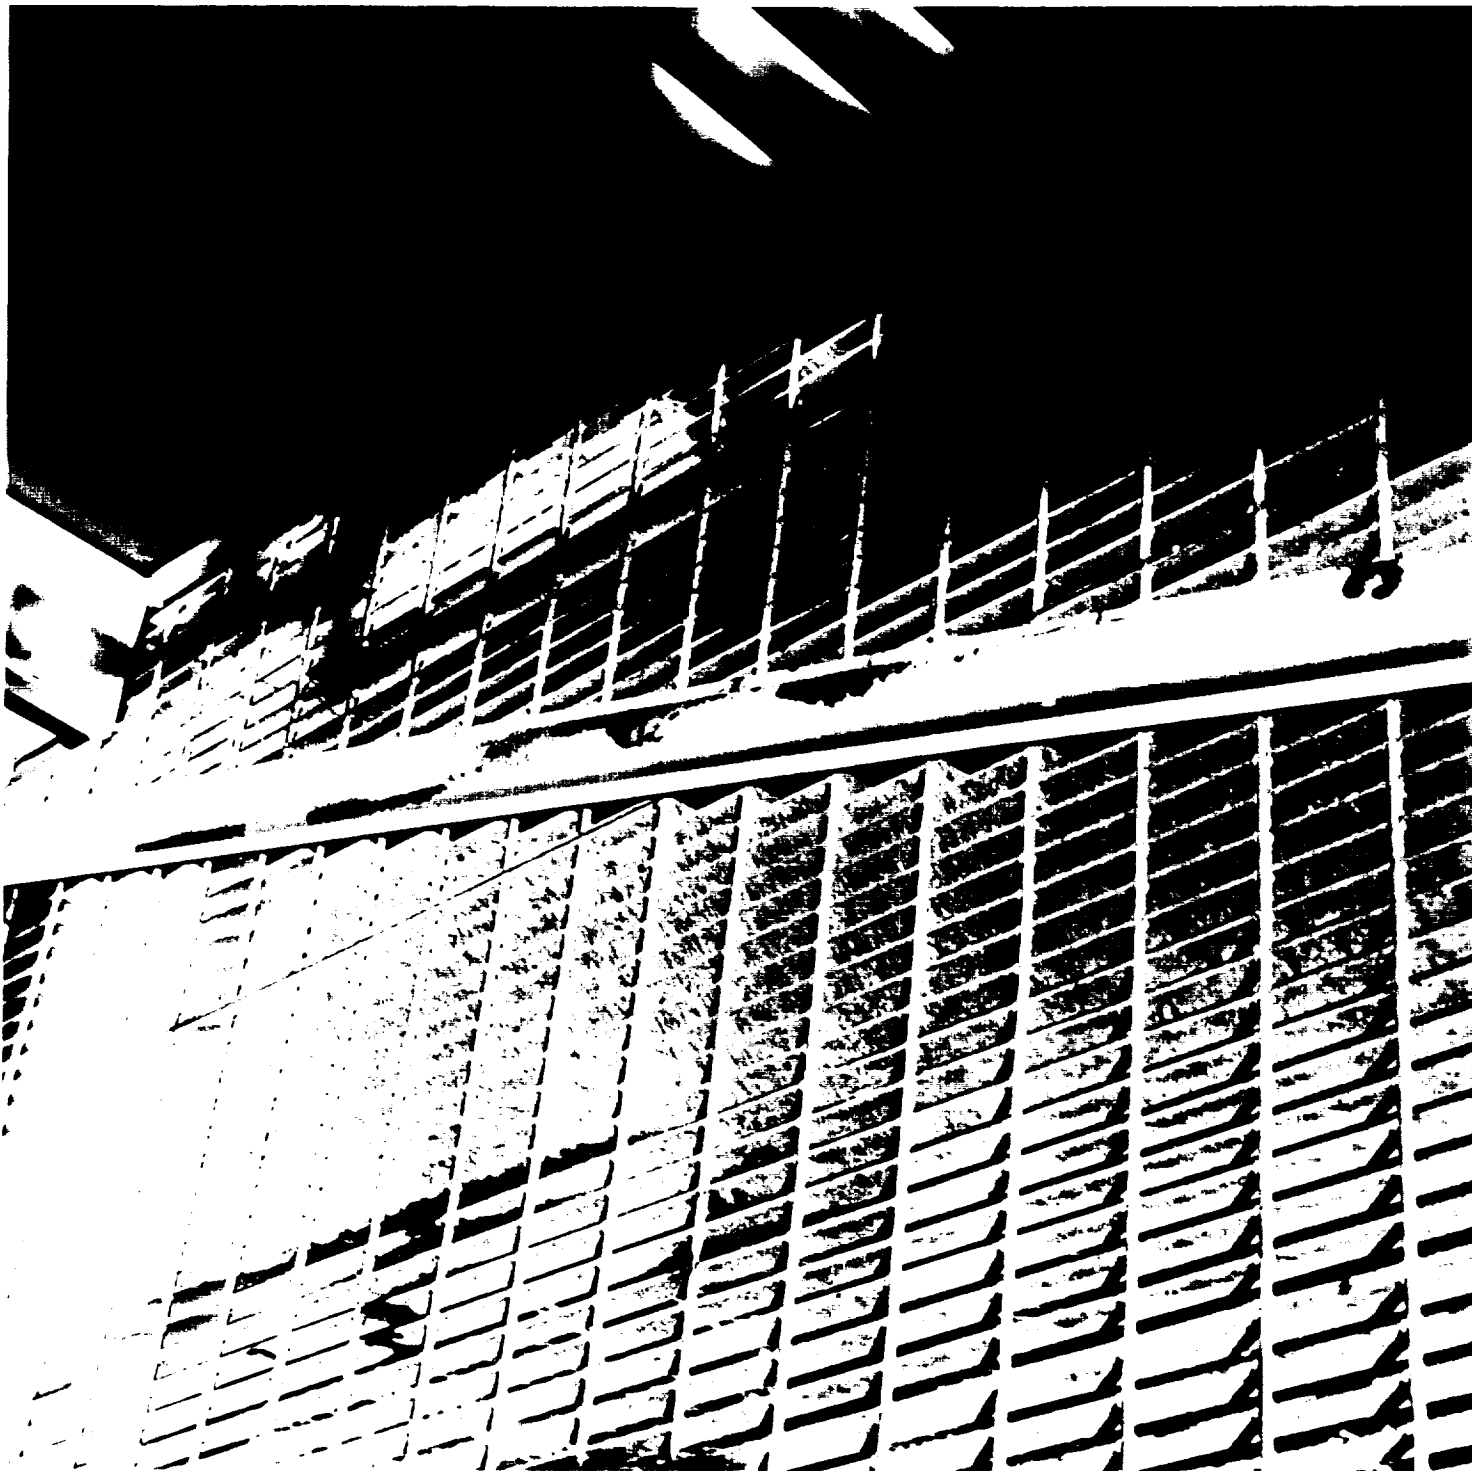
A 7-foot by 4-inch by 1/4-inch thick piece of sheet metal was found on the elevator south side FSS 175 foot level

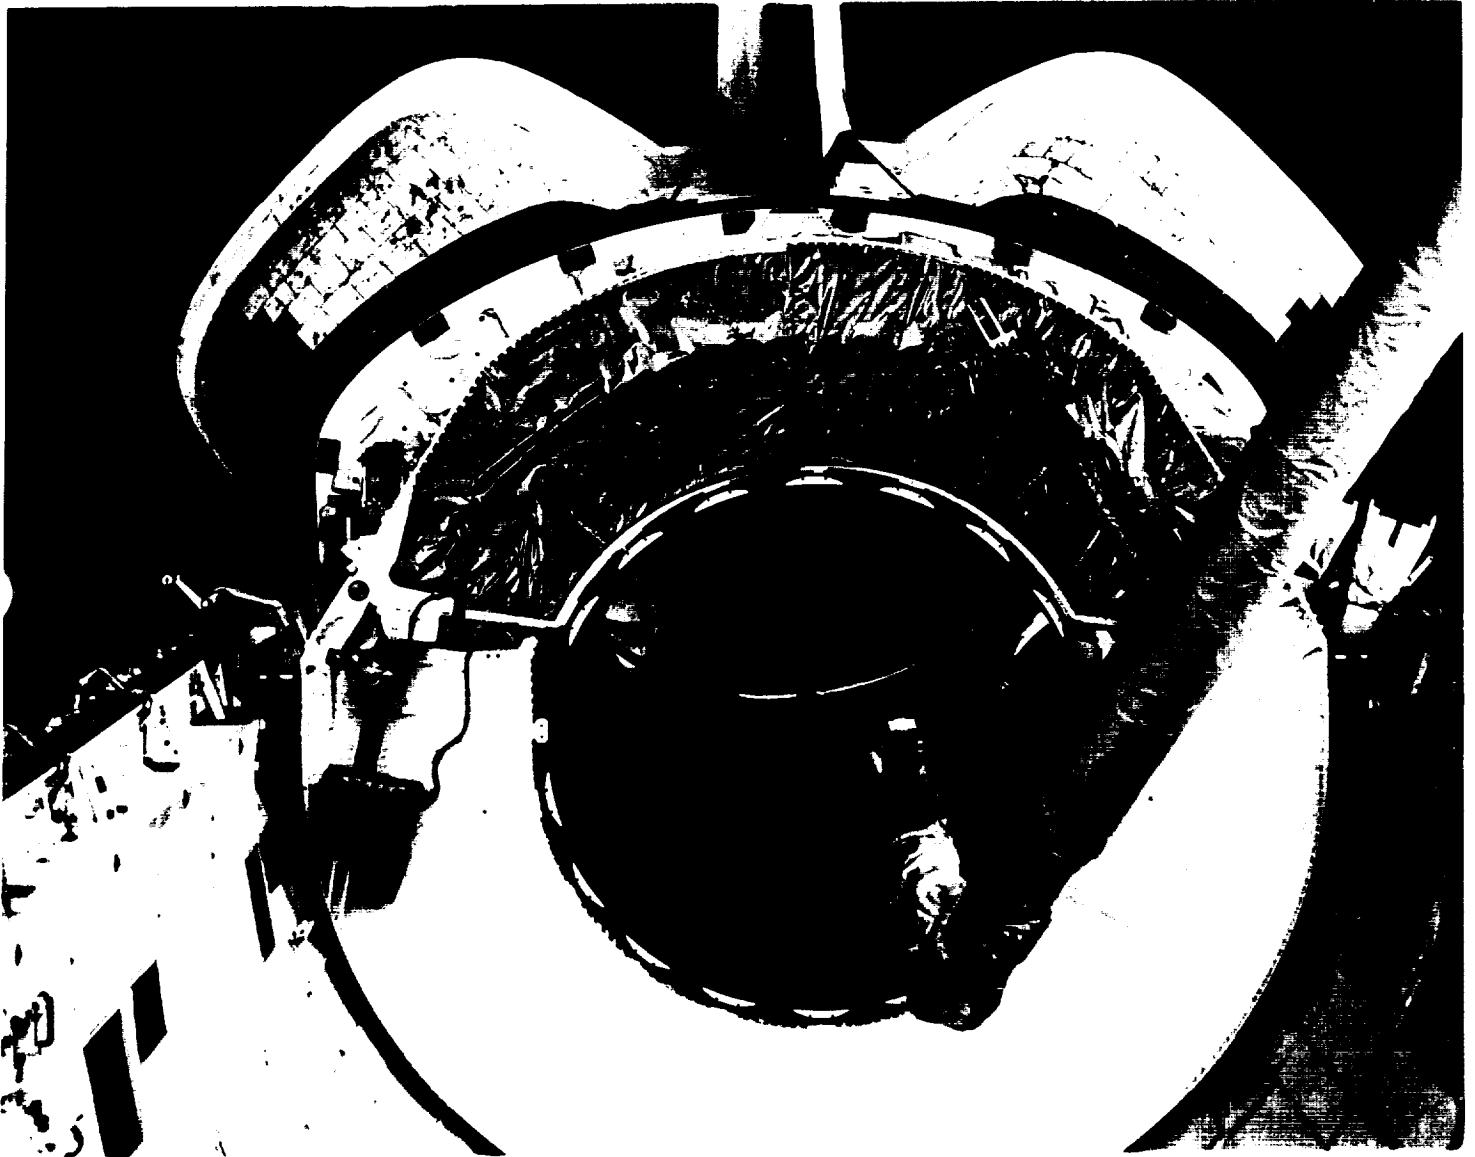
Debris from the Super*Zip anomaly caused 6 damage sites on the vertical stabilizer leading edge tiles. The LH OMS pod leading edge sustained a total of 18 tile damage sites.

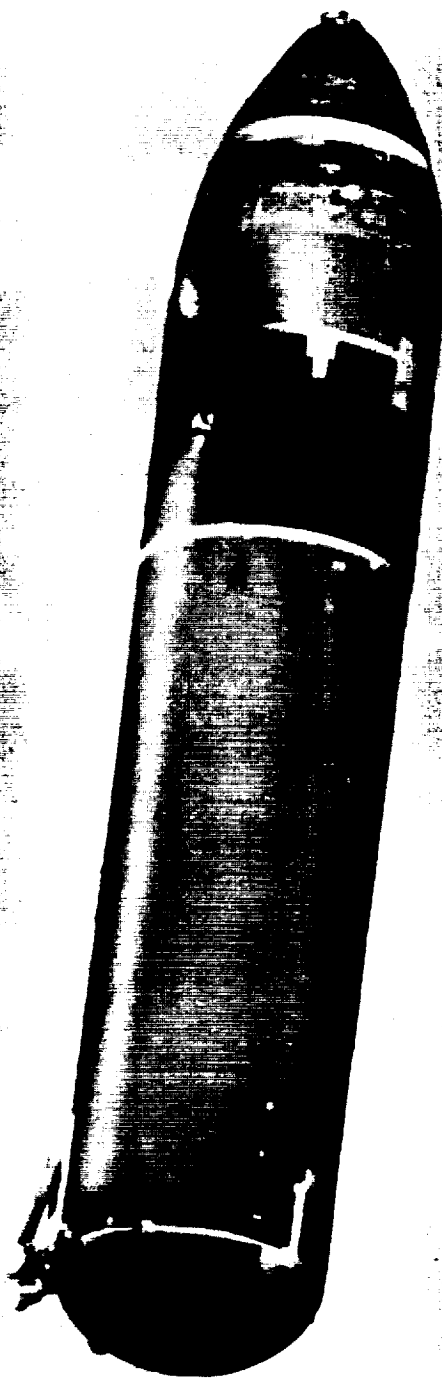
Three divots are visible in the LH2 tank-to-intertank flange closeout (arrows). The BSM burn scar on the LO2 tank and aft dome charring are typical. Scorch marks running the length of the ET from the EB fitting were caused by shock waves/air flow. There were no TPS anomalies on the LH2 and LO2 tank acreage.

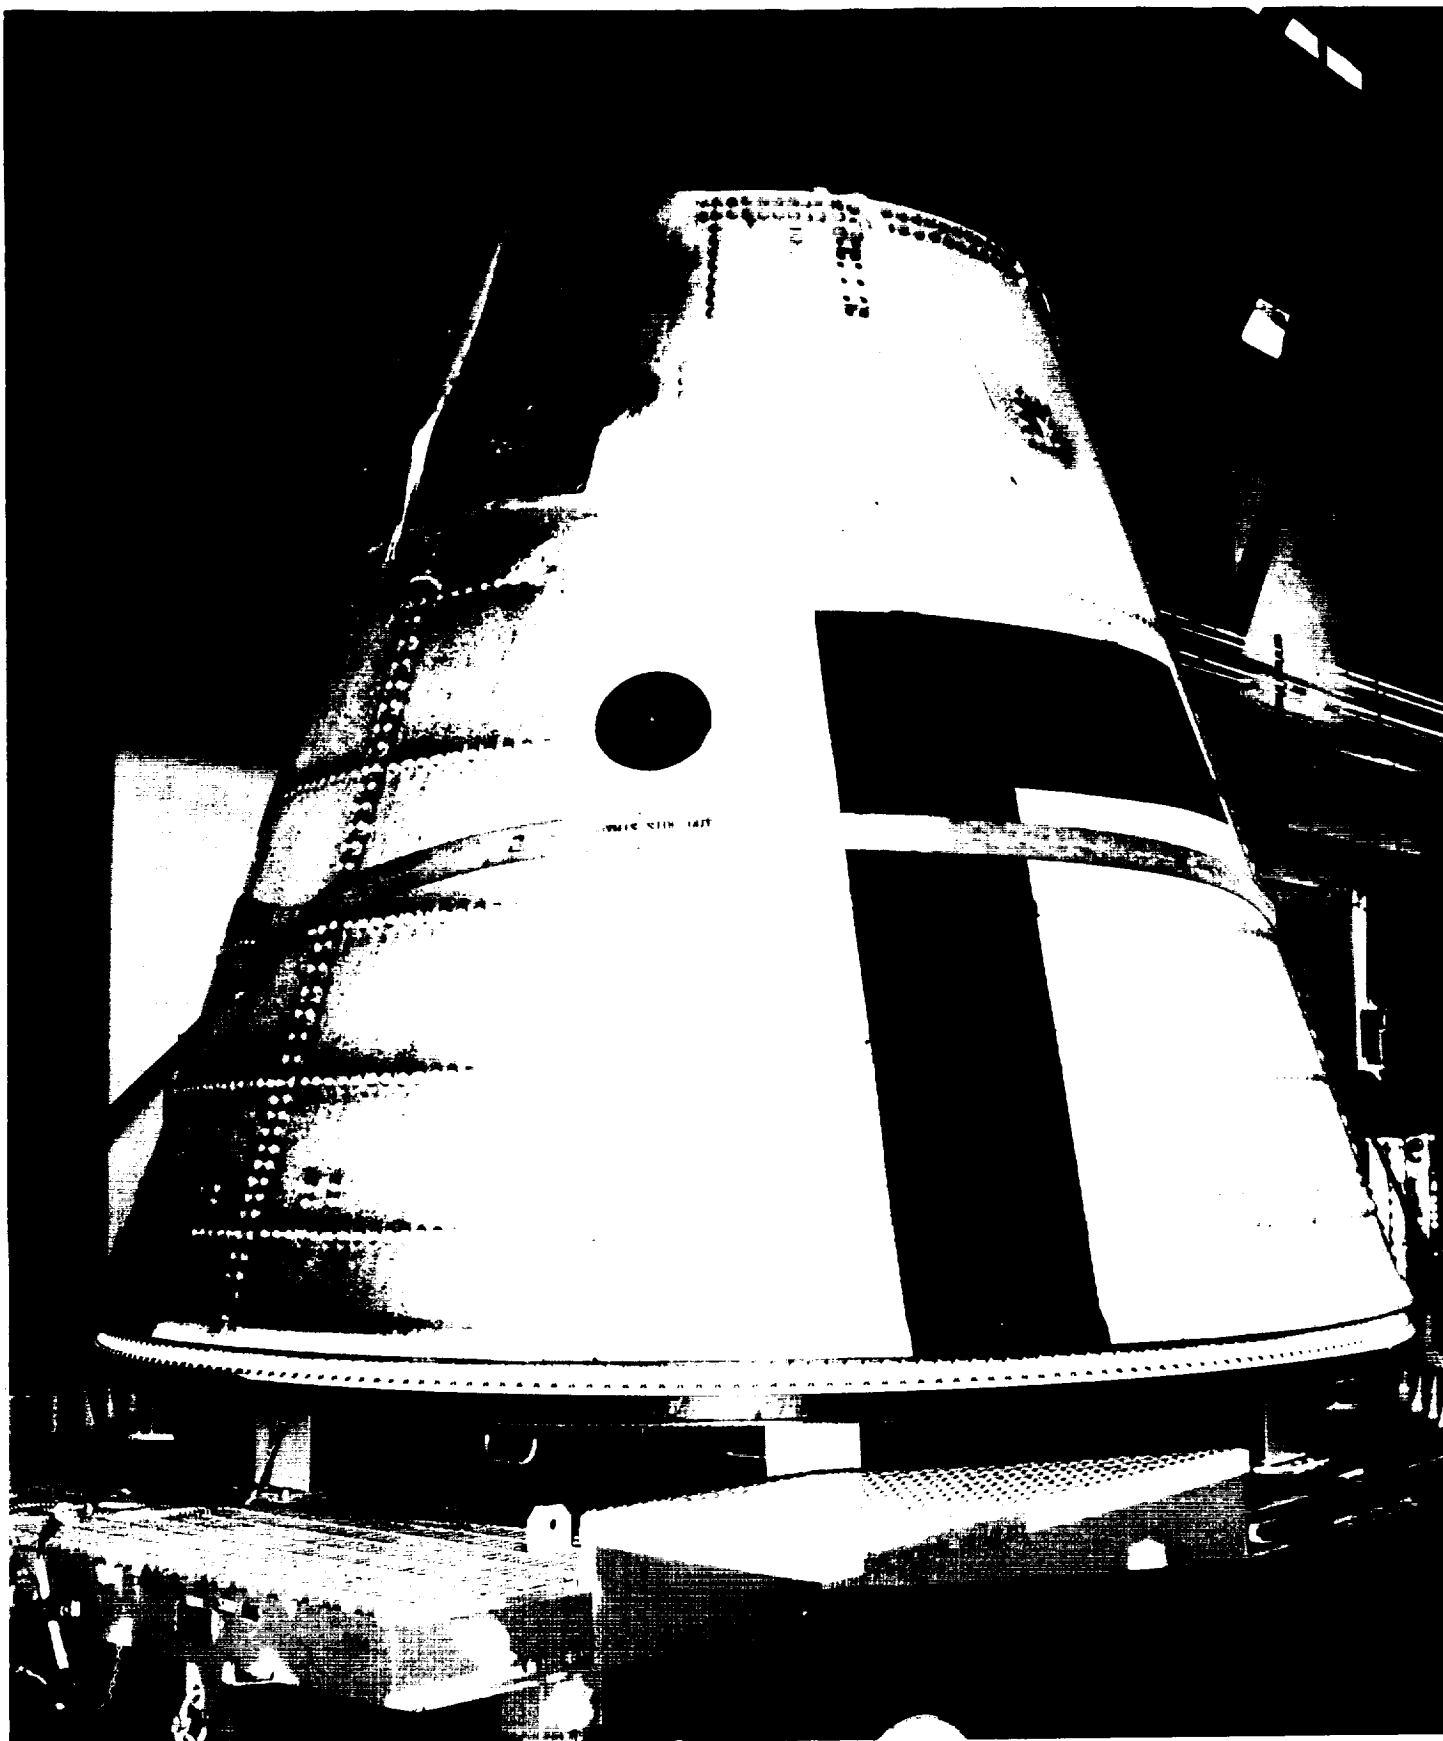
The RH frustum had 47 MSA-2 debonds over fasteners, but no missing TPS. All BSM aero heatshield covers were locked in the fully opened position.

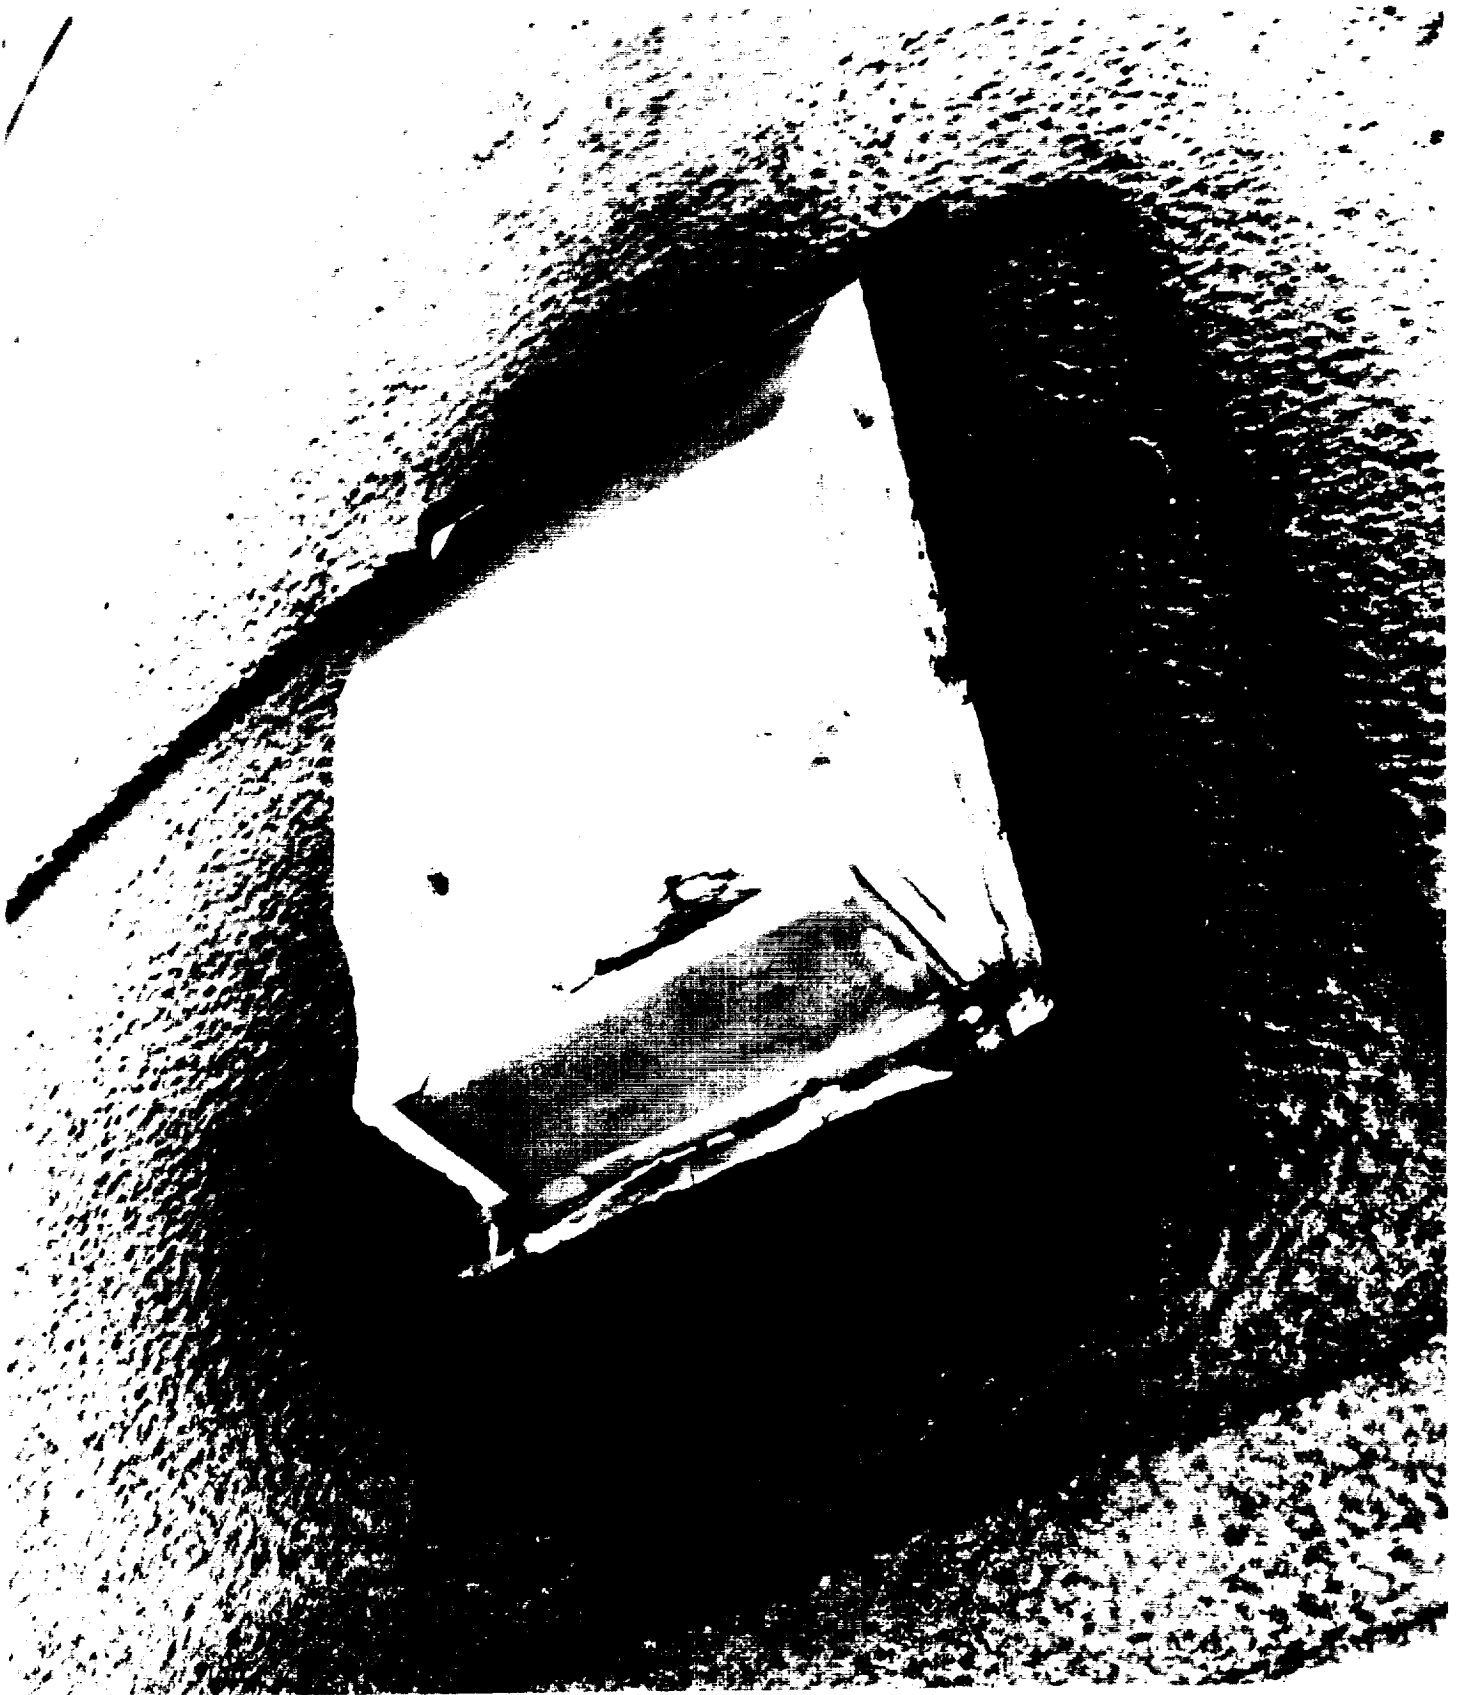
The 4Z RSS antenna cover was damaged and the phenolic base plate was missing. The substrate was not sooted and the damage most likely was the result of nozzle severance debris impact.

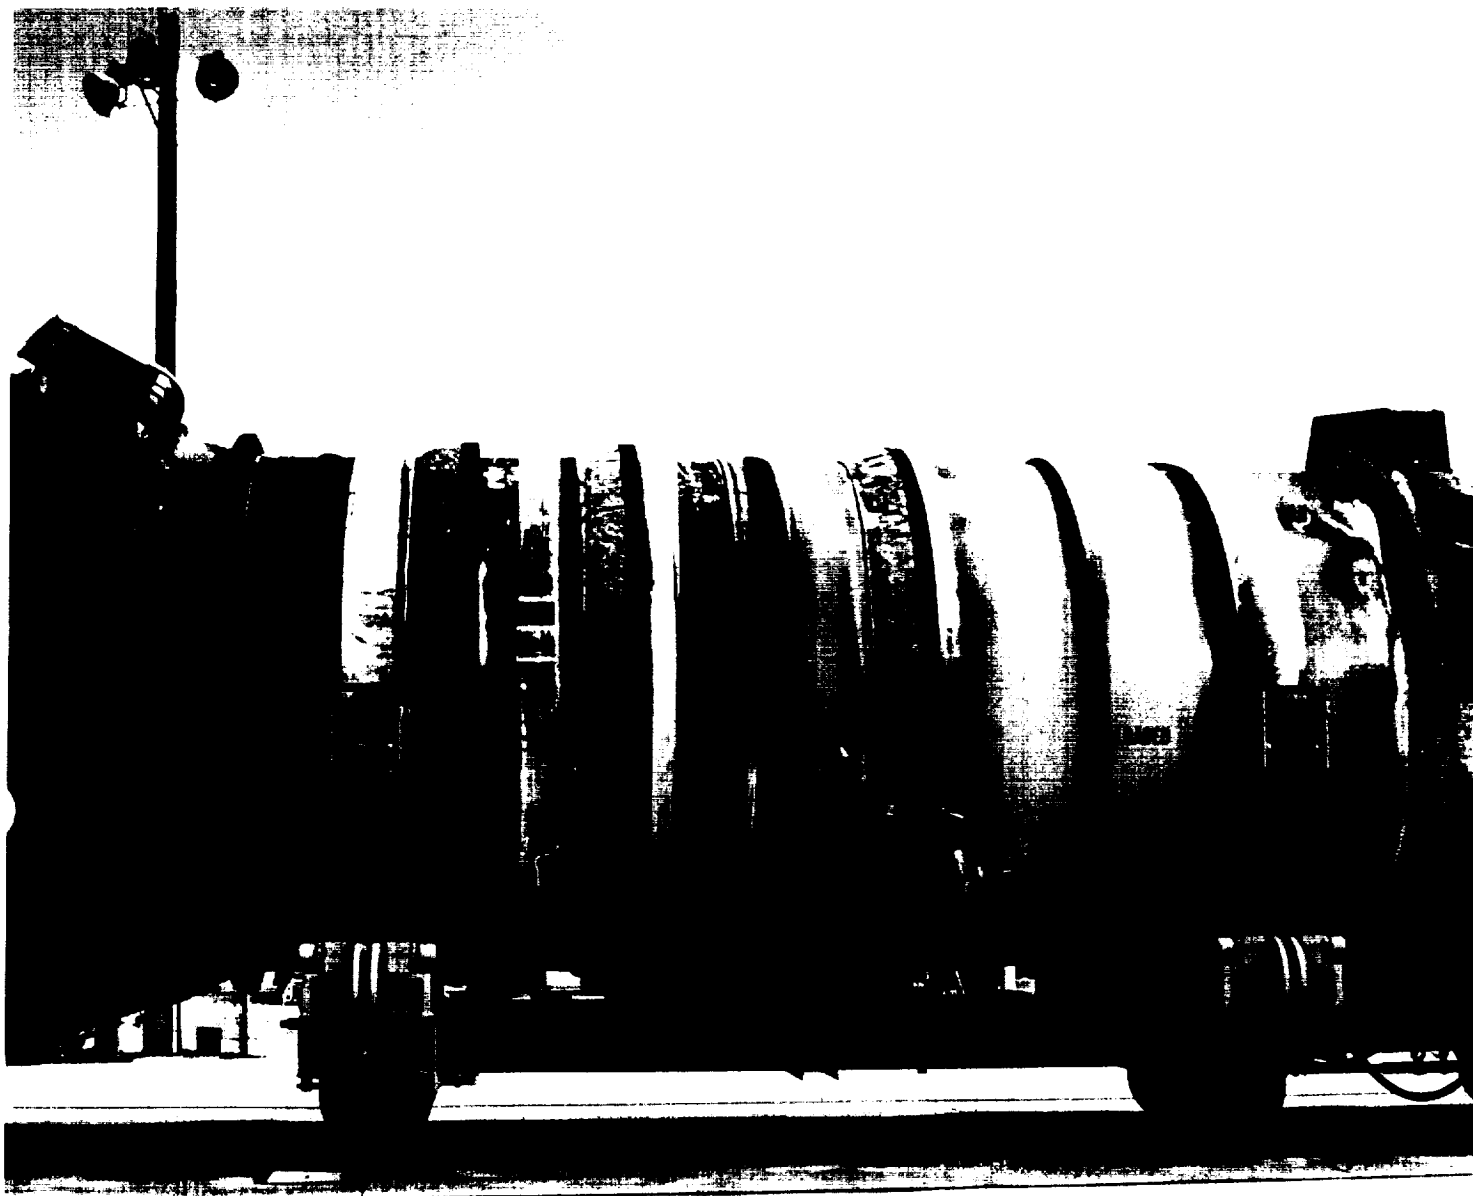
Post flight condition of the aft booster/aft skirt. A 3-inch diameter divot and 4 debonds occurred over aft skirt fasteners near the BSM's. A separation line was detected between the BTA and the adjacent cork.

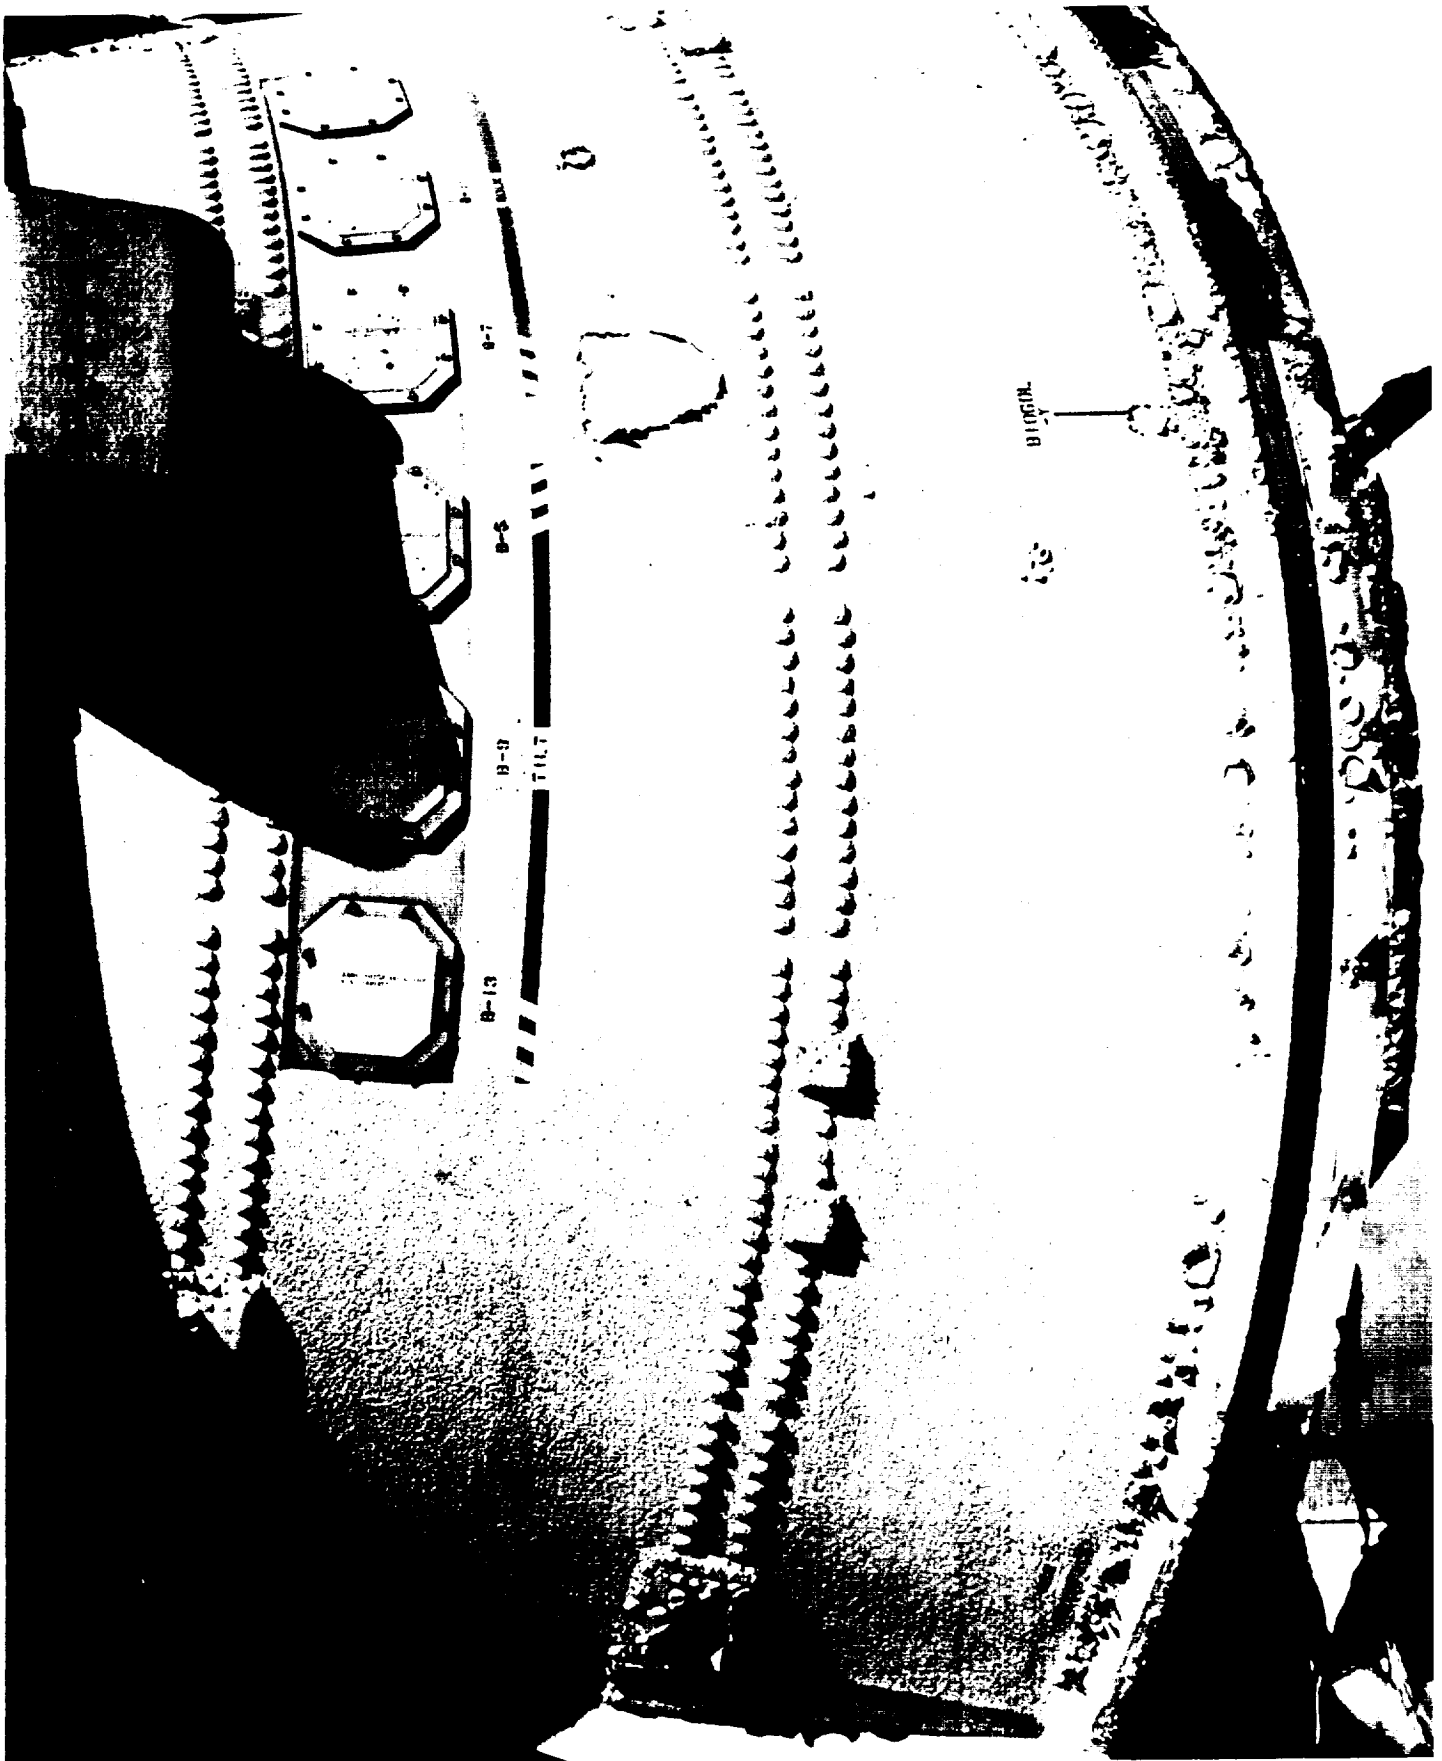
Hypalon paint was blistered and/or missing from numerous areas of Booster Trowellable Ablator on the aft skirt. The Hypalon paint is used as a topcoat to prevent moisture intrusion prior to launch, but is not required for thermal protection during flight. BTA, which is intended to replace K5NA closeouts, was applied for the first time as closeout TPS to general acreage areas.

Blistering and loss of Hypalon paint occurs most frequently when multiple coats of the paint are applied during pre-flight processing. A change to the application procedure could specify only one, thin coat of Hypalon.

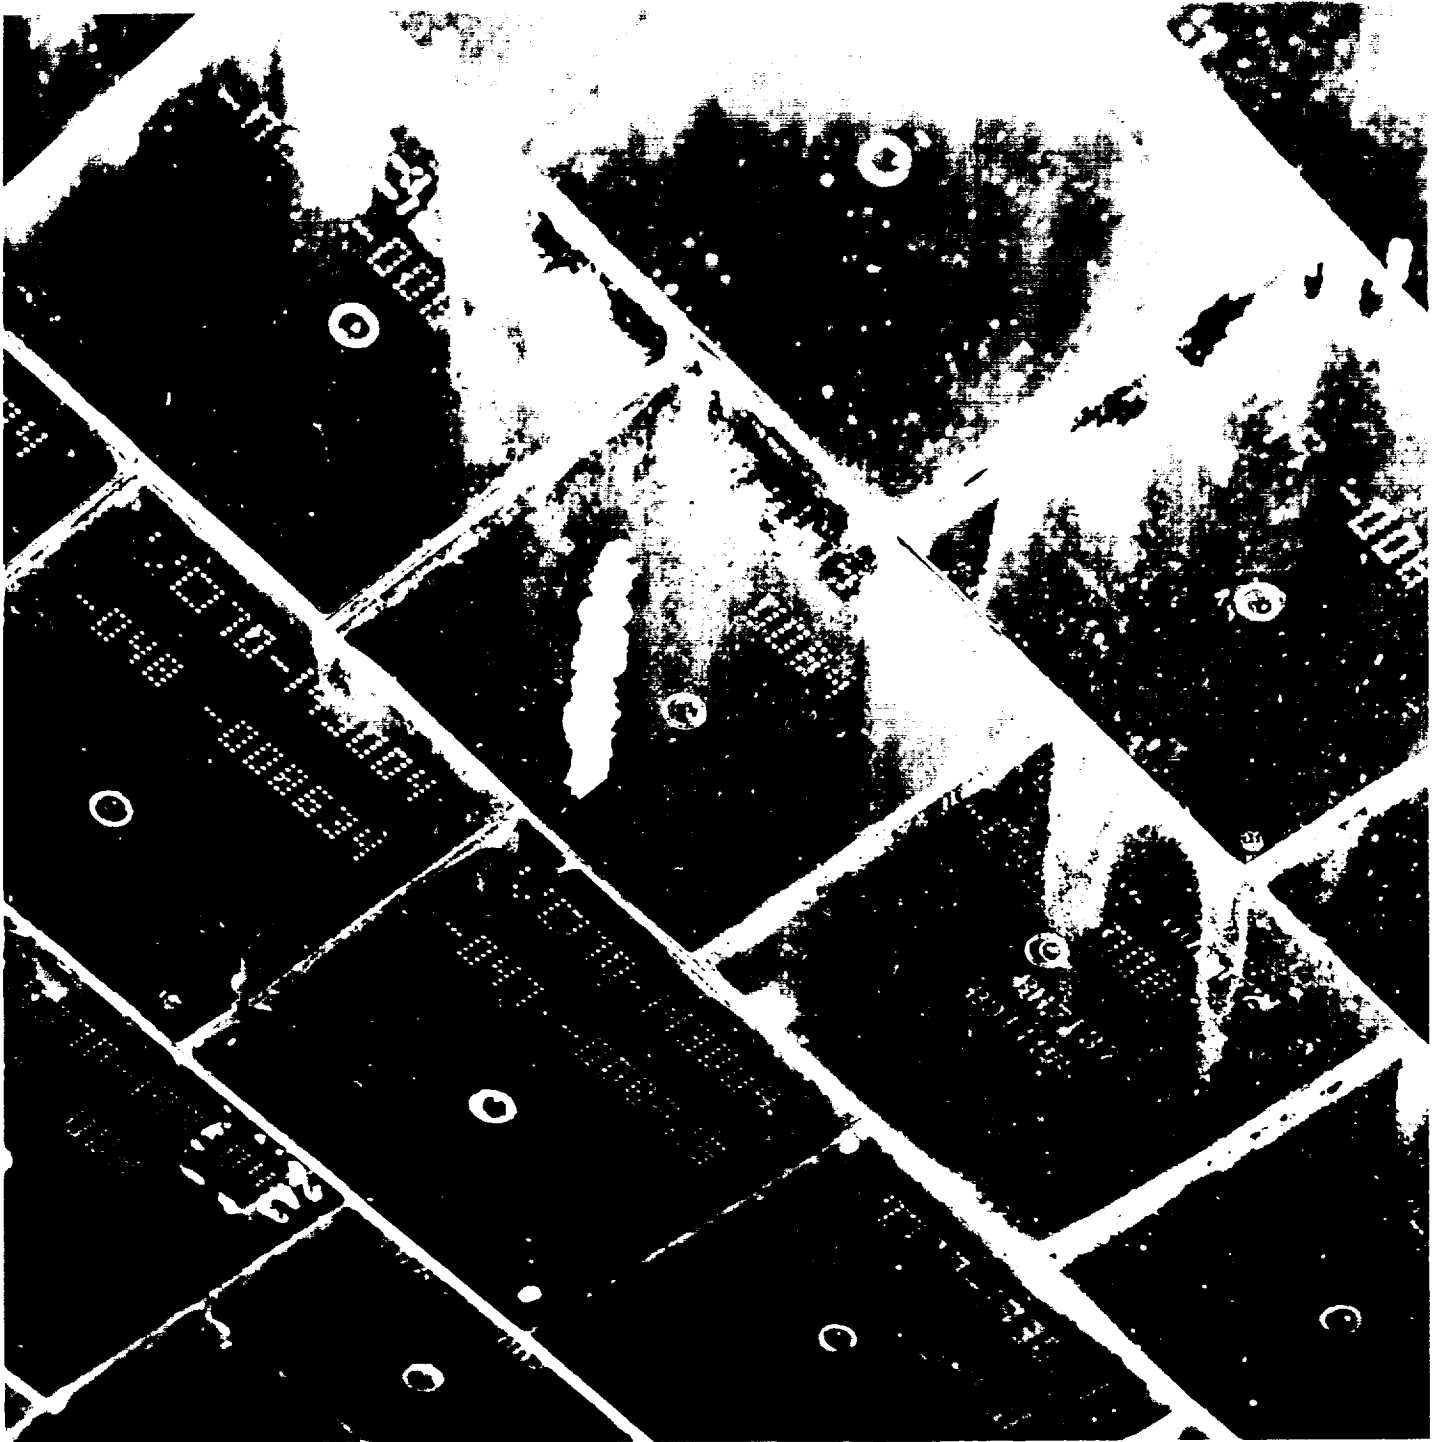
The largest tile damage site on the lower surface (RH inboard elevon) measured 3.75 inches long, 0.5 inches wide, and 0.25 inches deep.

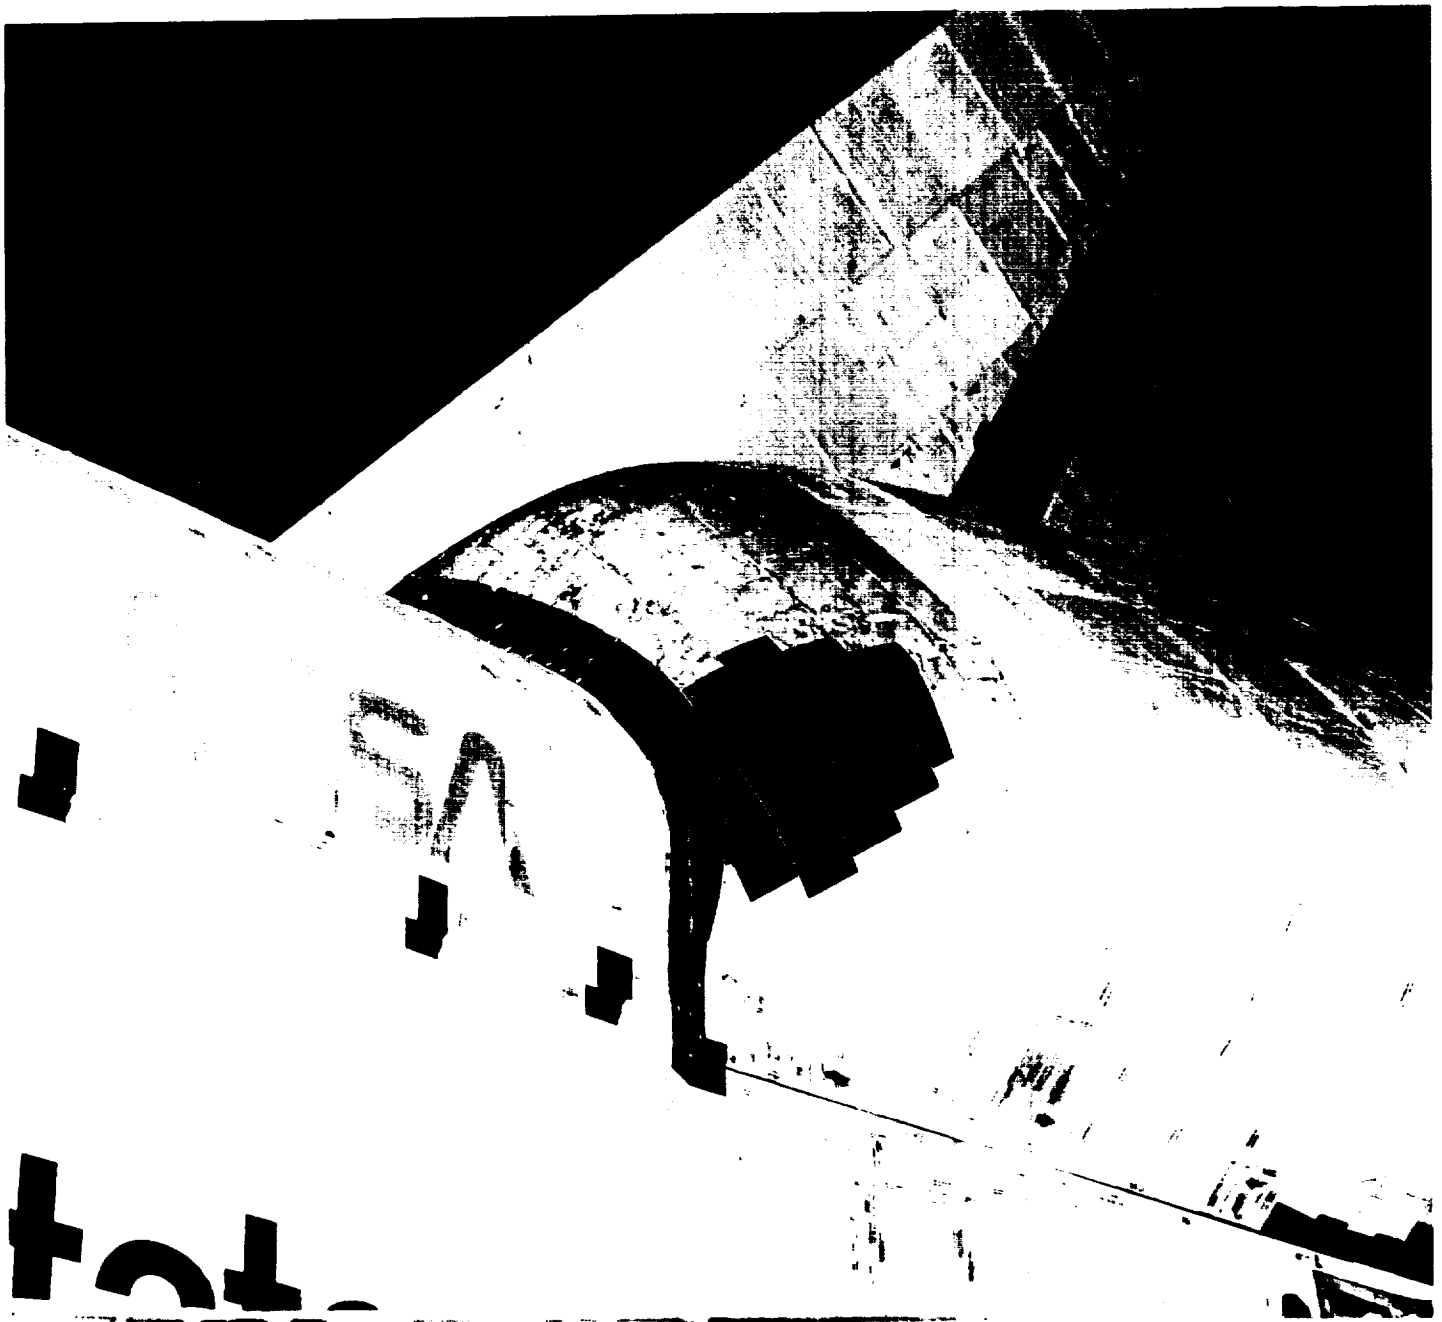
The left OMS pod leading edge sustained 18 tile damage sites. Seven of the hits were greater than one inch in length with depths ranging from 0.75 to 1.00 inch. The damage was caused by debris from the payload deployment TOS Super*Zip anomaly.
